**HOME**  
**PROPERTY**

**SCAN**  
**INSPECTIONS**

The following report was prepared for the buyers of the home and property at 1400 Main St. Anywhere City, Tennessee. The inspection was conducted on January 11, 2010 and began at 9:00 A.M. The age of the home is approximately 21 years. The weather at the time of the inspection was dry and sunny and the temperature was approximately 45 degrees. The home was occupied at the time of the inspection. The homebuyers were present for the inspection and the buyer's realtor was present as well.

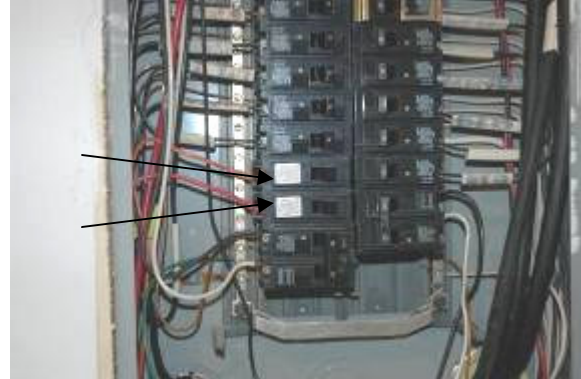
Circuit breakers #21 and #23 are Square D breakers and are not approved for this Siemens panel. These should be replaced with the proper Siemens breakers.

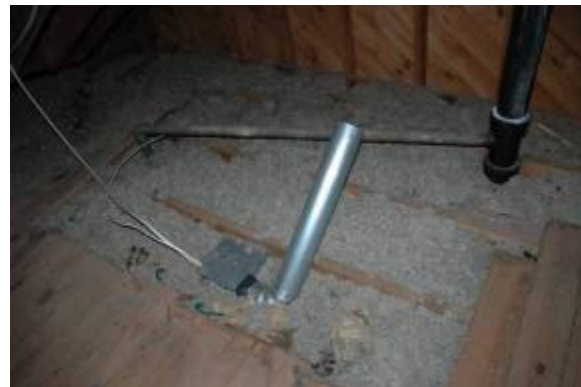
The bath exhaust fan duct should be extended to the vent or exterior.

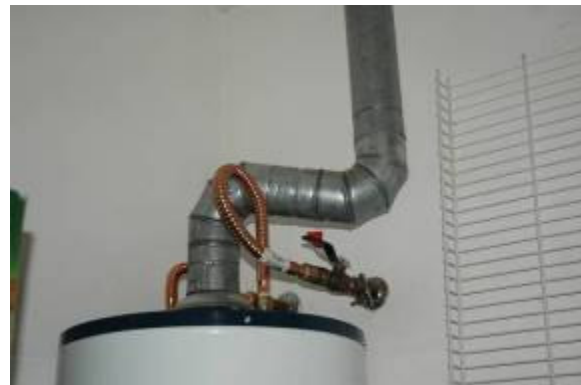
The vent for the water heater has an improper slope. This should slope a minimum of  $\frac{1}{4}$  inch per foot **toward the water heater**. This slope is away from the heater. This should be evaluated and repaired by a qualified professional

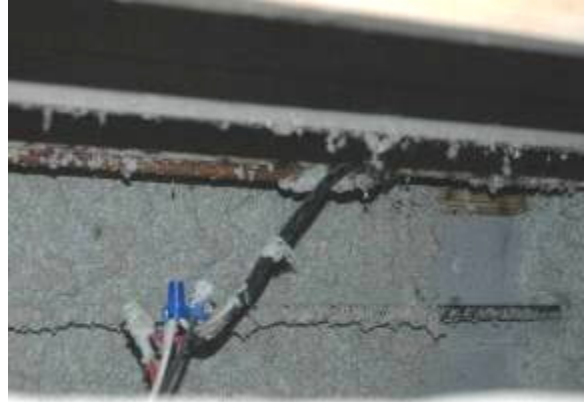
Open splices were noted in the crawl space. One was noted at the connection for the electronic air filter and the other in the feeder for the Carrier HVAC unit (approximately under the front door entry area). These splices should be contained in covered junction boxes.

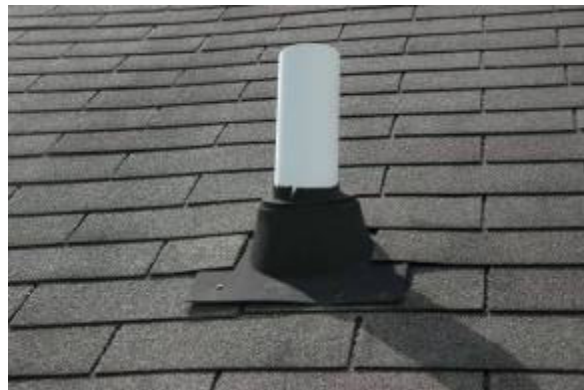
The plumbing vent on the left side roof has a split flashing boot and should be sealed.

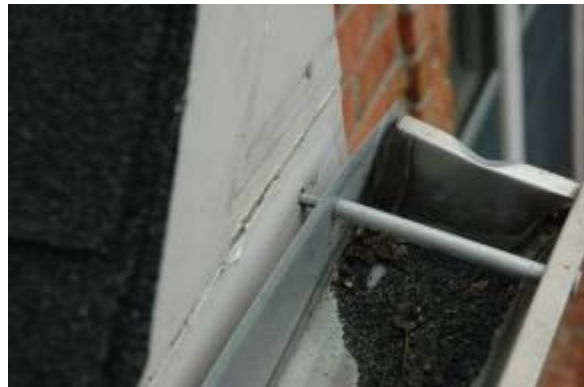
Several loose gutter nails were noted around the home. These should be properly secured.
